Contract #: 04-0120F4Cty: SF/ALA Rte: 80 PM: 13.2/13.9File #: 1.28**WELDING INSPECTION REPORT****Resident Engineer:** Siegenthaler, Peter**Address:** 333 Burma Road**City:** Oakland, CA 94607**Report No:** WIR-018137**Date Inspected:** 12-Nov-2010**Project Name:** SAS Superstructure**OSM Arrival Time:** 900**Prime Contractor:** American Bridge/Fluor Enterprises, a JV**OSM Departure Time:** 1730**Contractor:** American Bridge/Fluor Enterprises, a JV**Location:** Job Site

# WELDING INSPECTION REPORT

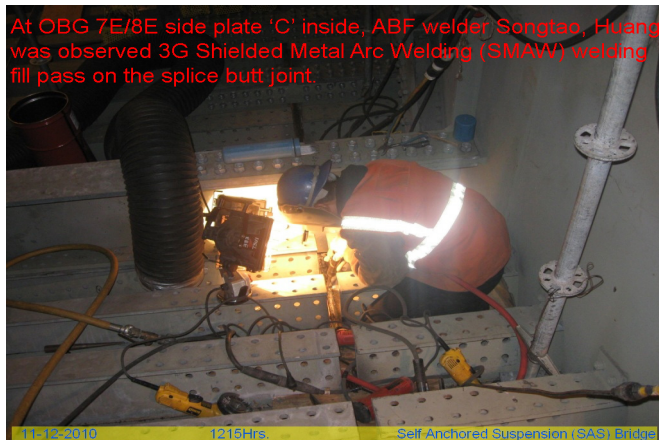
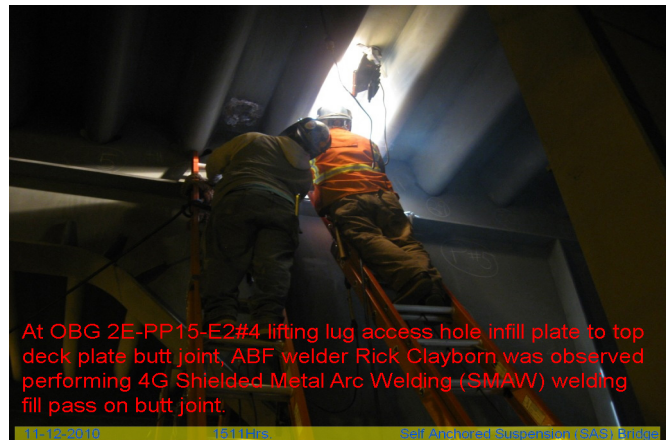
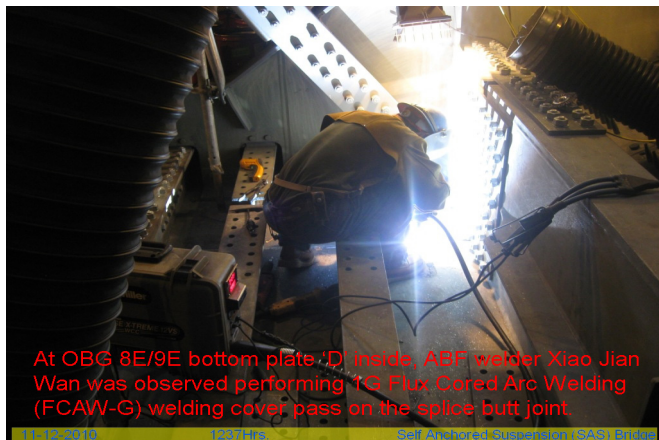
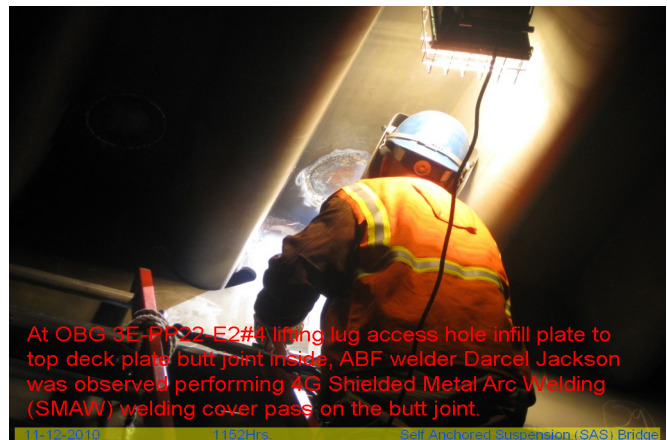
At OBG 7E/8E side plate 'C' (9755mm to 10555mm) inside, ABF welders Songtao, Huang was observed 3G SMAW welding fill to cover pass on the splice butt joint. This location was manually welded using the SMAW due to limited access when using the automatic FCAW-G track mounted Bug-o nozzle holder. The welder was using 1/8" diameter E7018H4R electrode and implementing Caltrans approved Welding Procedure Specification (WPS) ABF-WPS-D15-1040A. During welding, ABF QC William Sherwood was noted monitoring the welder's welding parameters. At the end of the shift, cover pass welding on location mentioned above was completed.

At OBG 8E/9E bottom plate 'D' inside, QA randomly observed ABF/JV qualified welders Xiao Jian Wan and Hua Qiang Huang perform Shielded Metal Arc Welding (SMAW) welding fill pass to cover pass on splice butt joint. The joint being welded has a single V-groove butt joint with backing bar. ABF welder Xiao Jian Wan was noted welding on the north side (600mm long) while the other welder was welding on the south side (1600mm long). The welders were using SMAW on these two locations due to limited access of the SAW track mounted feeder. Cover pass welding was completed on the north end but the fill pass welding on the south end was still continuing. During the shift, ABF QC William Sherwood was noted monitoring the welders.

1. At OBG 3E-PP20-E2#3 top deck plate outside – ABF welder Earl Espinosa was observed 1G SMAW welding fill to cover pass on the infill plate to top deck plate butt joint. The welder was noted using 1/8” diameter E7018H4R electrode implementing Caltrans approved Welding Procedure Specification (WPS) ABF-WPS-D15-1070. During welding, ABF QC Pat Swain was noted monitoring the welder’s welding parameters. At the end of the shift, cover pass welding on this location was completed.

2. At OBG 3E-PP22-E2#4 top deck plate inside - ABF welder Darcel Jackson was observed 4G SMAW back welding cover pass on the infill plate to top deck plate butt joint. The welder was noted using 1/8” diameter E7018H4R electrode implementing Caltrans approved Welding Procedure Specification (WPS) ABF-WPS-D15-1110A. During welding, ABF QC John Pagliero was noted monitoring the welder’s welding parameters. During the shift, cover pass welding on this location was completed and the welder has moved to access hole #2 of the same location which was also completed except the grinding/cleaning of the gouged groove of the joint.

3. At OBG 2E-PP15-E2#4 top deck plate inside - ABF welder Rick Clayborn was observed 4G SMAW back welding fill pass on the infill plate to top deck plate butt joint. The welder was noted using 1/8” diameter E7018H4R electrode implementing Caltrans approved Welding Procedure Specification (WPS) ABF-WPS-D15-1110A. During welding, ABF QC John Pagliero was noted monitoring the welder’s welding parameters. During the shift, fill pass welding on this location was still continuing which should remain Monday.
